## TECHNICAL STATUS

The project was divided into two separate tasks: an aboveground survey of several sections of pipeline, and excavation/observation of pipeline condition. Survey techniques employed included DCVG, ACVG, PCM, Pearson, and C-Scan. For the recent work, three separate sections, each 100-200' long, were surveyed and excavated.

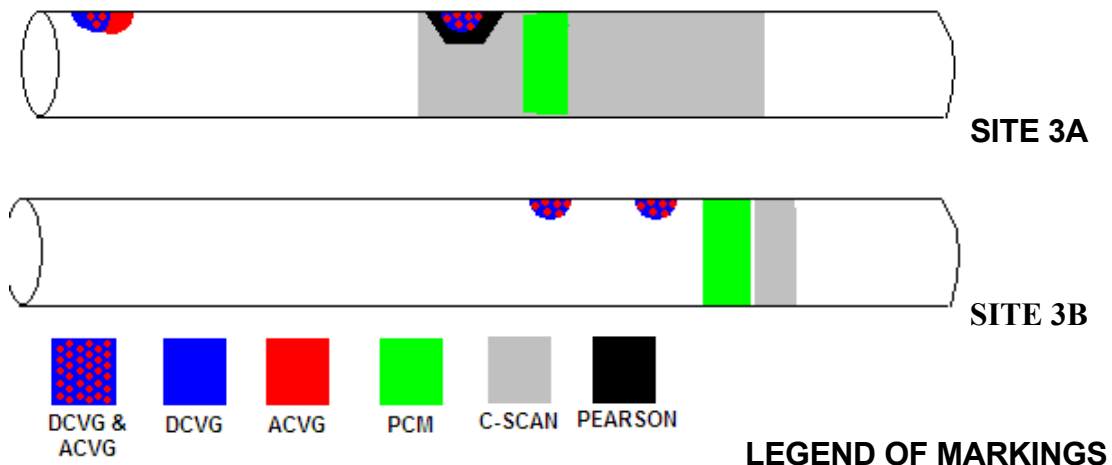
Figures 1-2 are diagrams of the defects predicted vs. defects discovered upon excavation. Several defects were not detected by any technique. Most defects that were discovered and interpreted to be on top of the pipeline were, in fact, oriented farther down towards the bottom.

**Figure 1:** Site representations of defects found with aboveground surveys

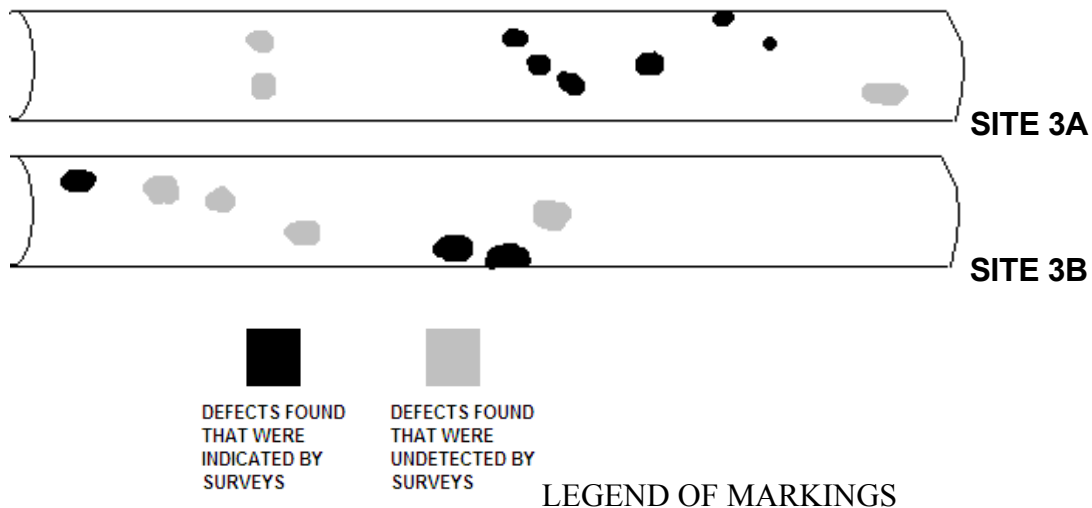
**Figure 2:** Representations of actual defect sites found upon excavation
